PERIODIC REVIEW

**Modern Machinery
Facility Site ID#: 97995414**

**22431 83rd Avenue S.,
Kent, Washington**

March 2010

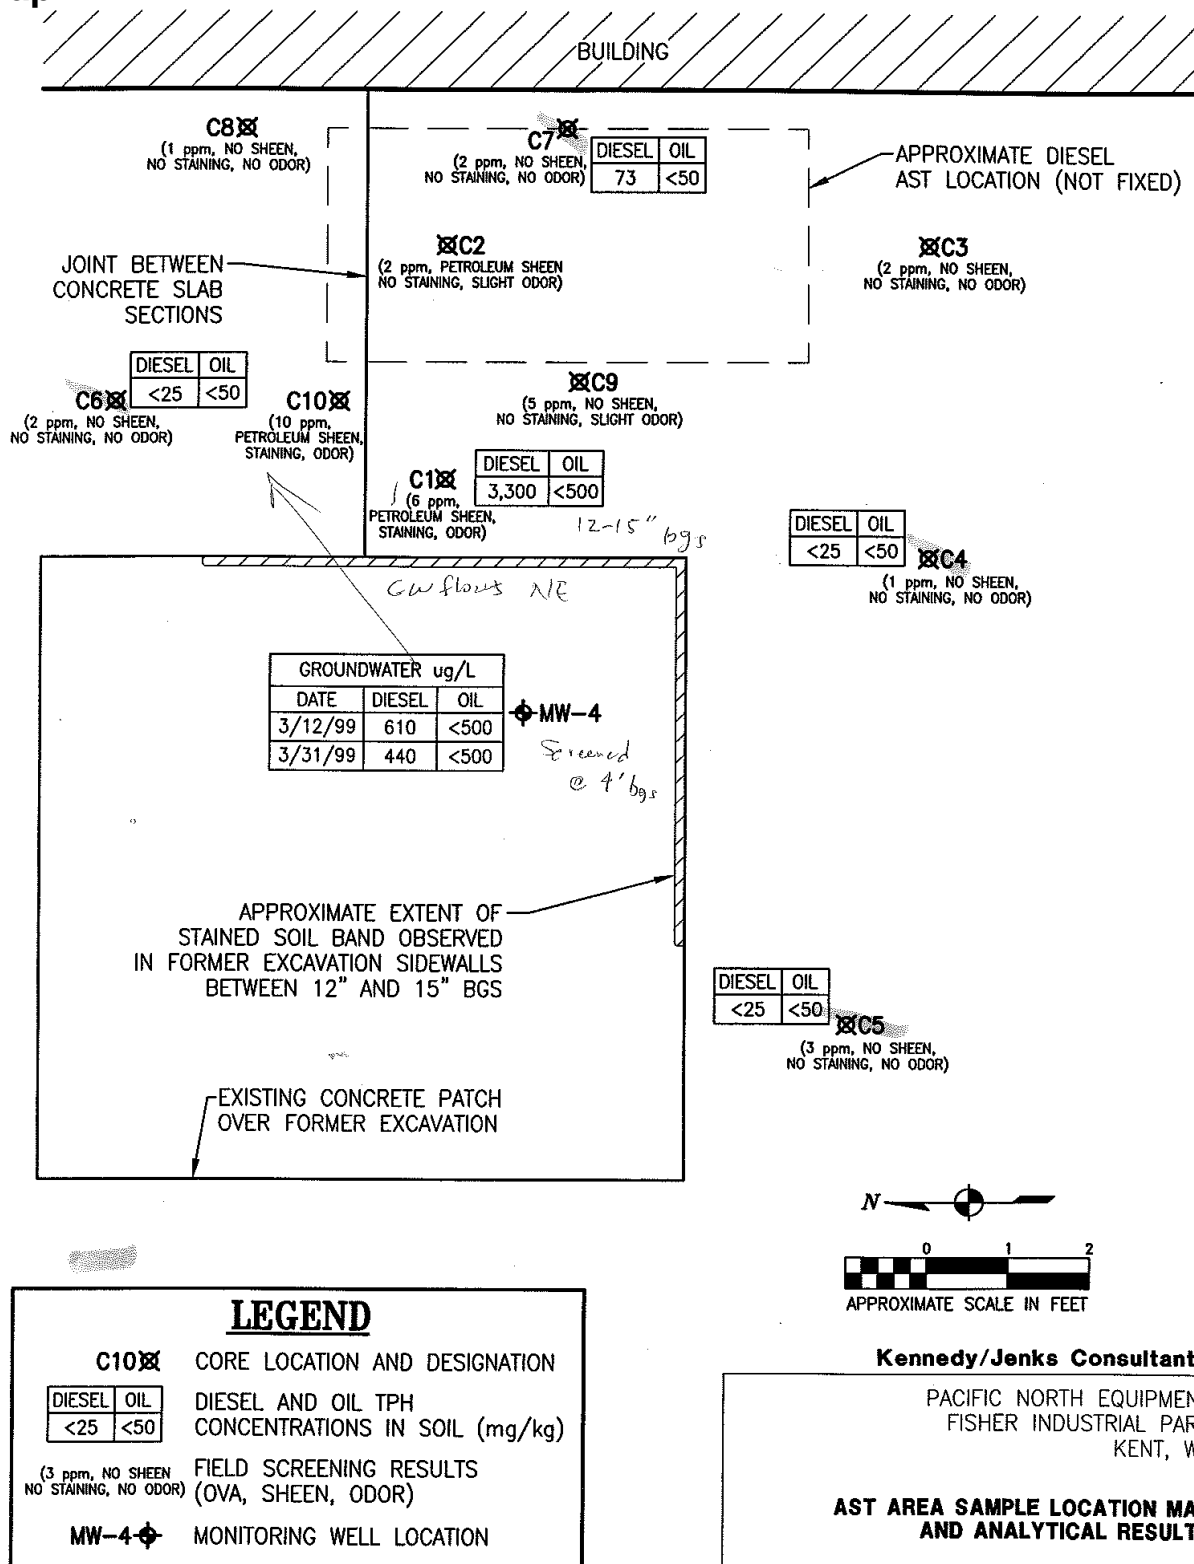
6.3 AST TPH Concentration Map

Diesel range TPH were detected in the soil at P-10, in the area of one of the ASTs on the west side of the garage, at a concentration of 1,400 mg/kg, which is above the 200 mg/kg MTCA Method A cleanup level. The sample was collected from approximately 0.5 to 3.0 feet bgs and was likely the result of surface infiltration through the cracks and seams in the concrete beneath the AST adjacent to P-10. Heavy staining was noted on the concrete beneath the ASTs on the south side of the garage and adjacent to P-10. Probe numbers P-7 and P-8 were also advanced in the location of the two ASTs on the south side of the garage. TPH were not detected in the soil at these locations.

The remediation work undertaken in the AST area was completed on October 31, 1997. Soil excavation was performed by Global Environmental and observed by Kennedy/Jenks Consultants. Overlying concrete was sawcut and broken apart with a backhoe-mounted breaker. The limits of the soil excavation were guided based on field screening of grab samples and observation of visual evidence of petroleum contamination. The excavation measured approximately 8 feet by 8 feet. Petroleum affected soil was initially encountered at a depth of approximately 2 feet bgs and extended vertically to a depth of approximately 3 to 3.5 feet bgs. Petroleum affected soil was not observed to extend laterally past the edges of the excavation with the exception of a 1 to 2 inch thick "band" of discolored soil that was observed on the eastern and southern excavation sidewalls at a depth of 12 to 15 inches bgs. The band was laterally continuous for several feet but terminated along the south and east sidewalls. The grayish color of the band suggested that the soil in this thin zone had been exposed to petroleum, which had since weathered significantly. During a telephone consultation on the day of the excavation work, Ms. Melissa Papworth of Kennedy/Jenks Consultants and Ms. Gretchen Miller of Shannon & Wilson, Inc., agreed that further excavation in the AST area to remove the thin band of discolored soil was not warranted. Soil that appeared to contain petroleum was loaded directly onto a truck and transported to Rabanco for use as cover in their Roosevelt, Washington, Subtitle D landfill. A total volume of approximately 7 tons (5 cubic yards) of petroleum affected soil was removed from the excavation. Kennedy/Jenks Consultants collected a confirmation soil sample from the excavation bottom at a depth of 3.5 feet bgs. The confirmation soil sample was submitted to ARI for analysis by Ecology Method WTPH-D. Diesel range TPH was not detected in the sample. Petroleum affected soil in the AST area was excavated and disposed off-Site. The thin zone of discolored soil observed in the AST area did not appear to pose a threat to human health or the environment according to the consultants involved.

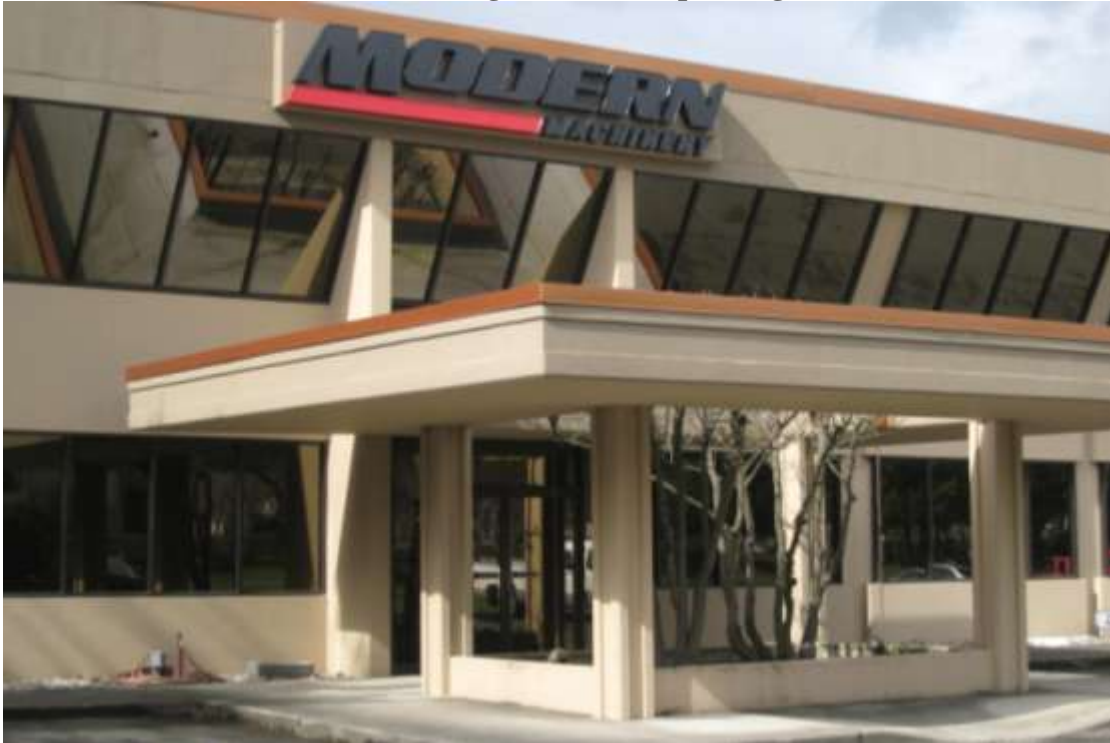
Photo 1: Front entrance of office buildings - from east parking lot

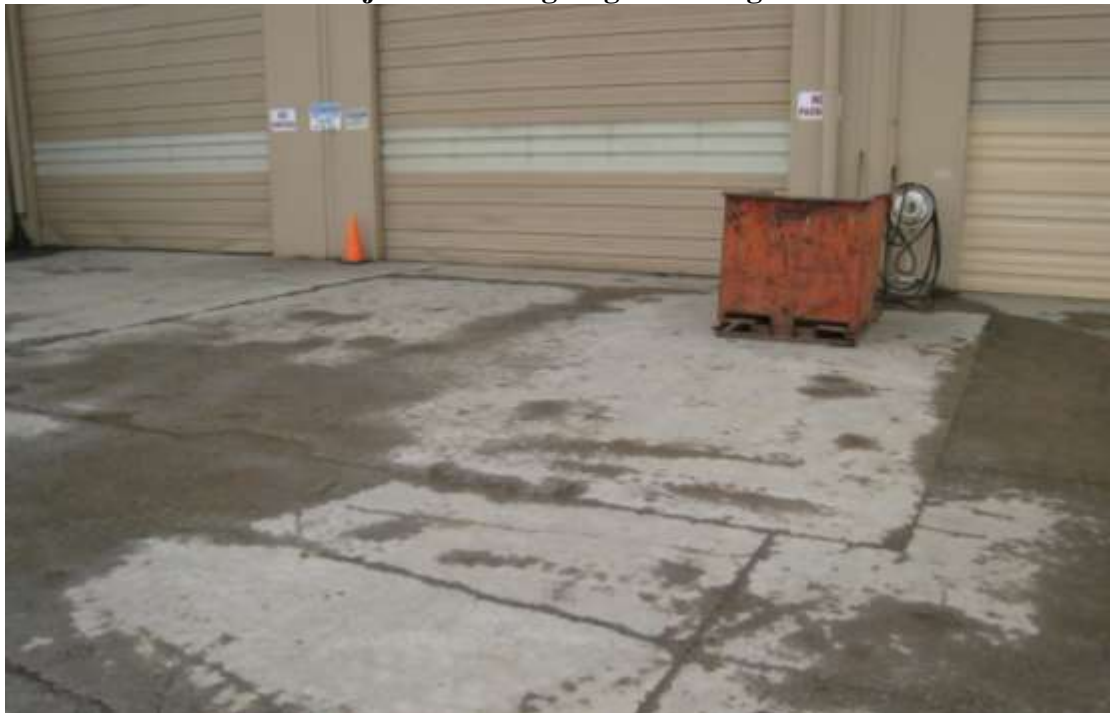
Photo 2: Waste oil tank area adjacent to the garage - looking the south

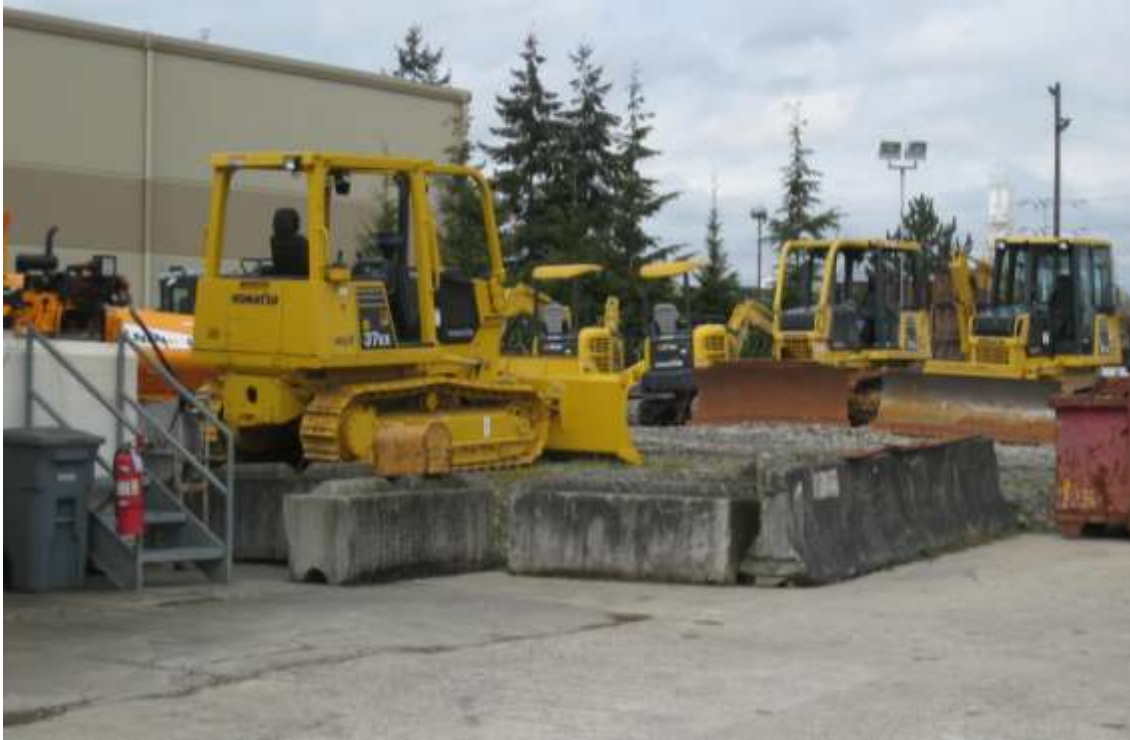
Photo 3: Area near Paint House and Wash Rack, former USTs - looking northwest

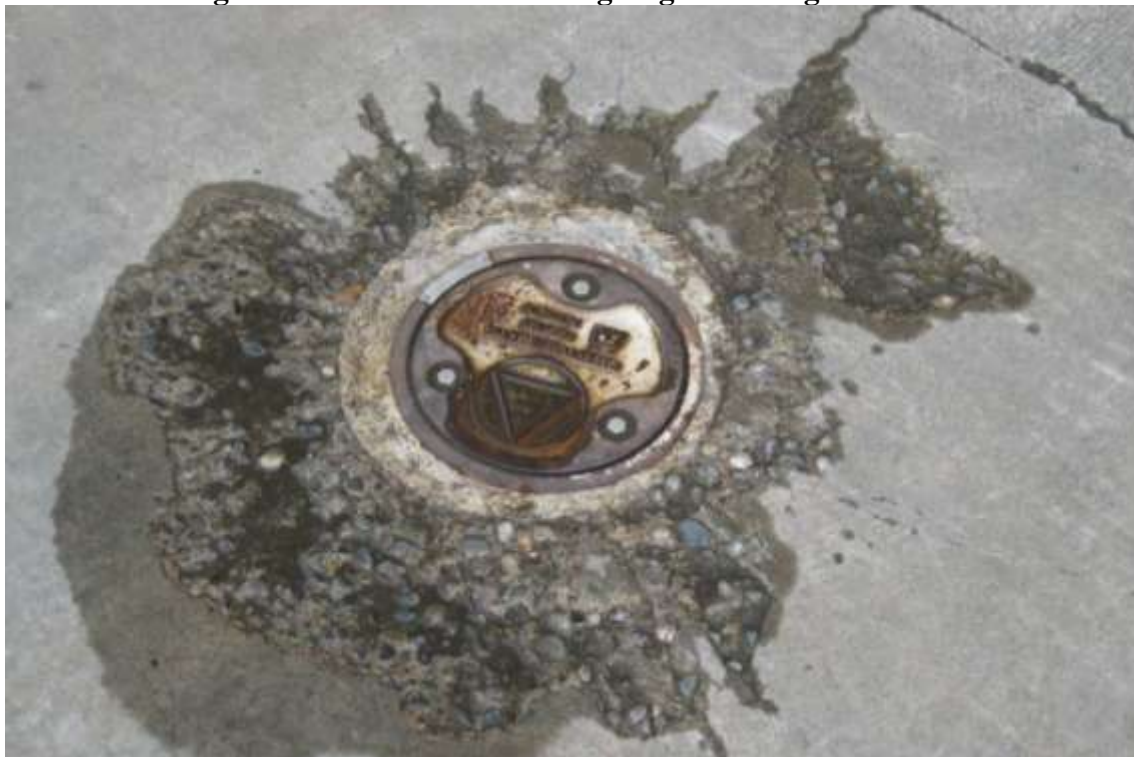
Photo 4: Monitoring well at the west end of the garage building
